ANODIC ETCHING - A METHOD OF DETECTING
GRINDING BURNS ON CHROMIUM PLATED STEEL PARTS

Northrop Corporation
Hawthorne, California

7 February 1975

NOR-75-33

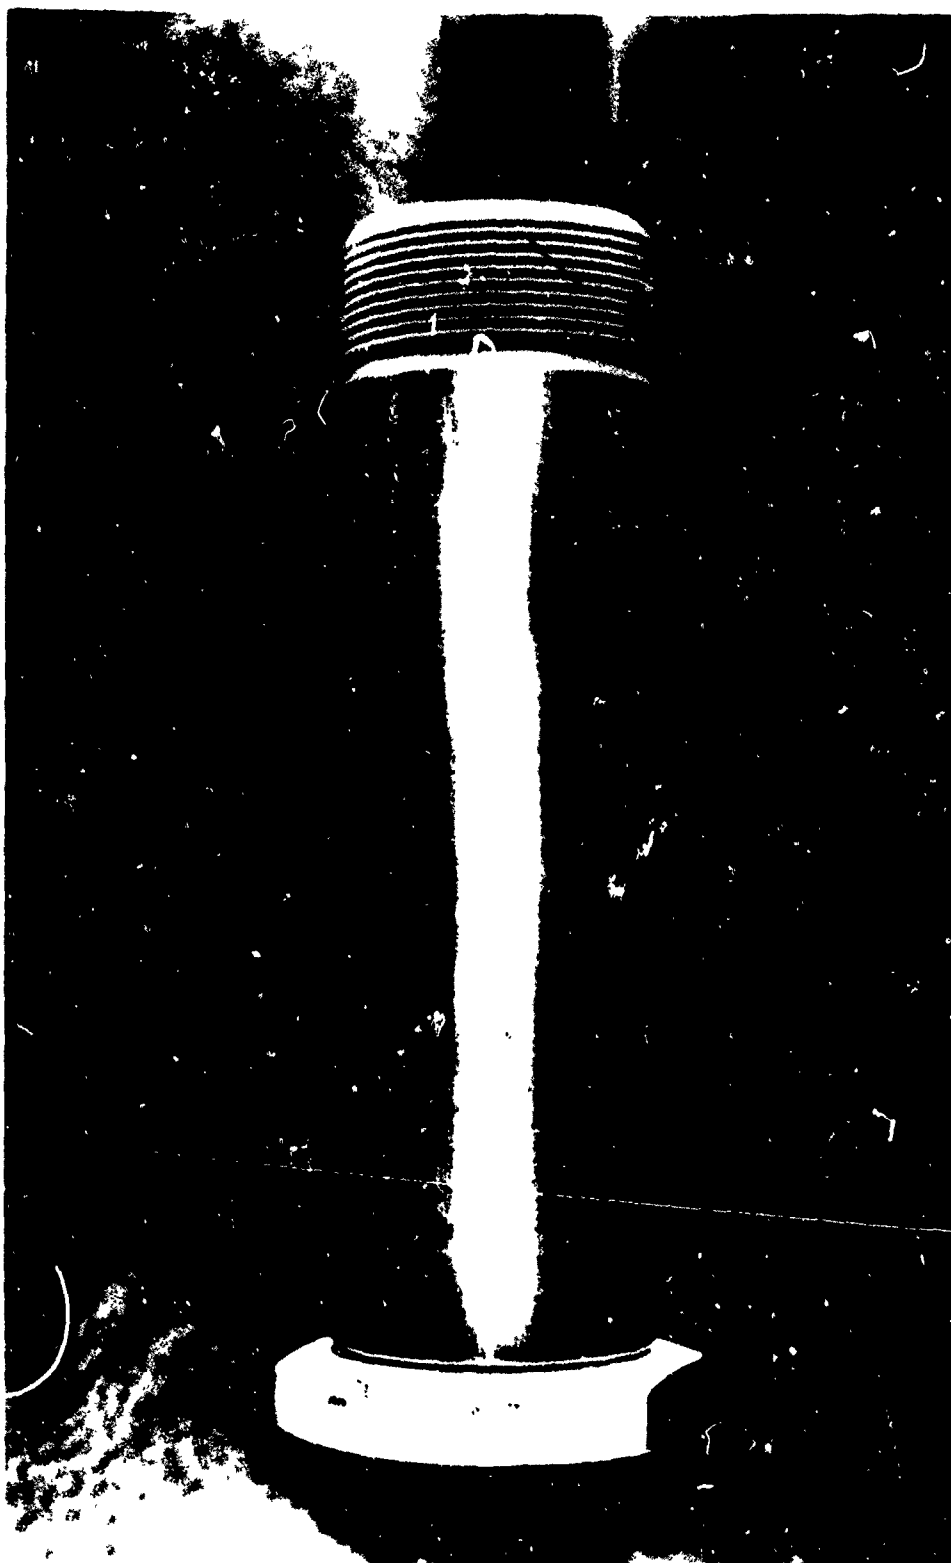
FIGURE 1. CHROMIUM PLATED MAIN WING ATTACH PIN
USED FOR TEST PROGRAM

Four steel pins were selected for evaluation that were scrapped due to evidence of grinding checks on the chromium plate. These pins were made from 300M bar and were heat treated to 280 to 300 ksi ultimate strength. They were chromium plated on the 1.75 inch diameter to a thickness of $0.003 \text{ inch} \pm 0.0001$. A typical pin is shown in Figure 1. Each of the pins were identified as 1,2,3,or 4 by vibratory etching

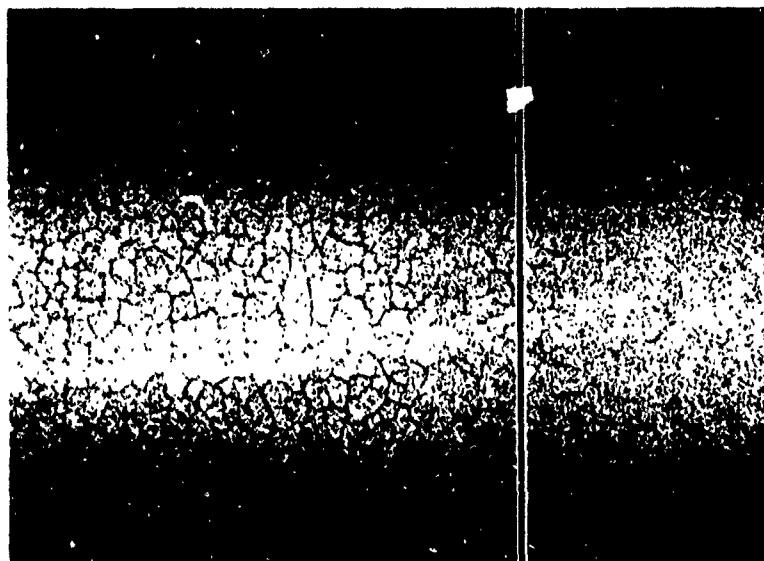
FIGURE 4. MUD CRACK PATTERN IN DAMAGED AREA OF CHROMIUM
PLATE REVEALED BY ANODIC ETCHING

The spiral mark on the chromium plate revealed by anodic etching is not really a burn. Instead, a gross cracking of the chromium plate is being revealed in the so-called burned area as compared to the unburned area. This effect is shown in Figures 4 and 5. The gross cracking (mud cracking) in the damaged areas reflects light differently than the normal chromium plate (haze).

MUD CRACKED CHROME

GOOD CHROME

The haze is normal for all chromium plating and represents the normal crack pattern of this inherently "cracked" plate. The mud cracks are results of thermal heating and cooling of the plate due to overheating from improper grinding. The cooling of the overheated plate causes large cracks to form through the normal plate. These mud cracks are what is seen after anodic etching and indicate damage.

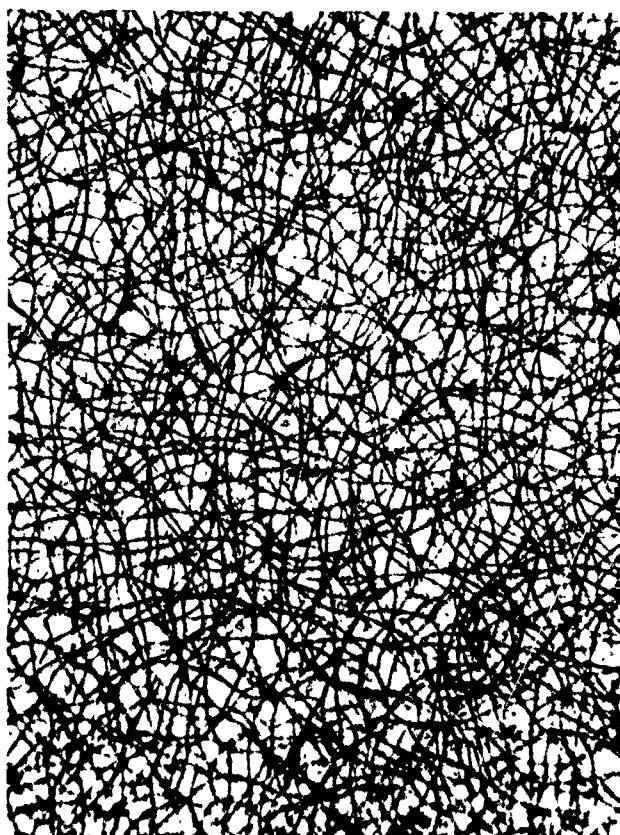
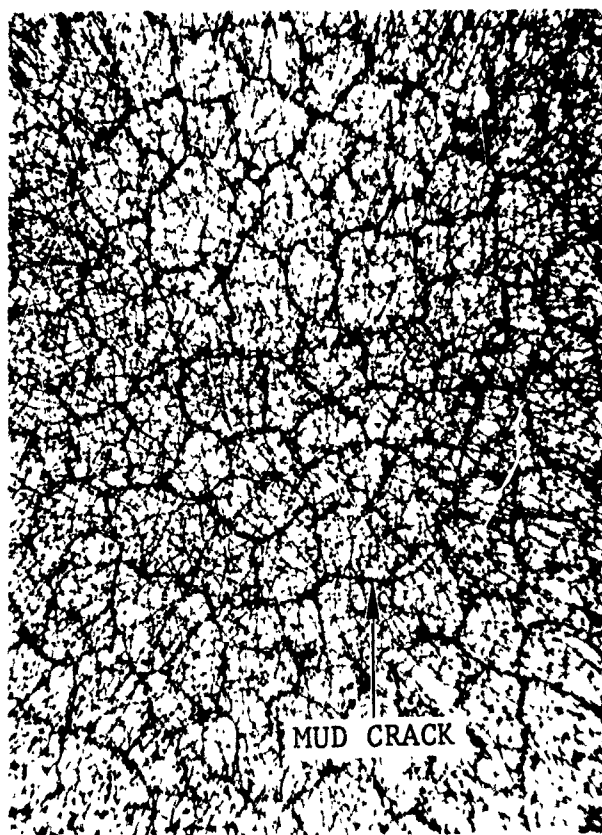
FIGURE 5. SURFACE OF NORMAL CHROMIUM PLATE AFTER ANODIC ETCHING

HAZE EVIDENT ON NORMAL PLATE

MUD CRACKS EVIDENT ON DAMAGED PLATE

TRANSITION BETWEEN ETCHED AND GROUND PLATE

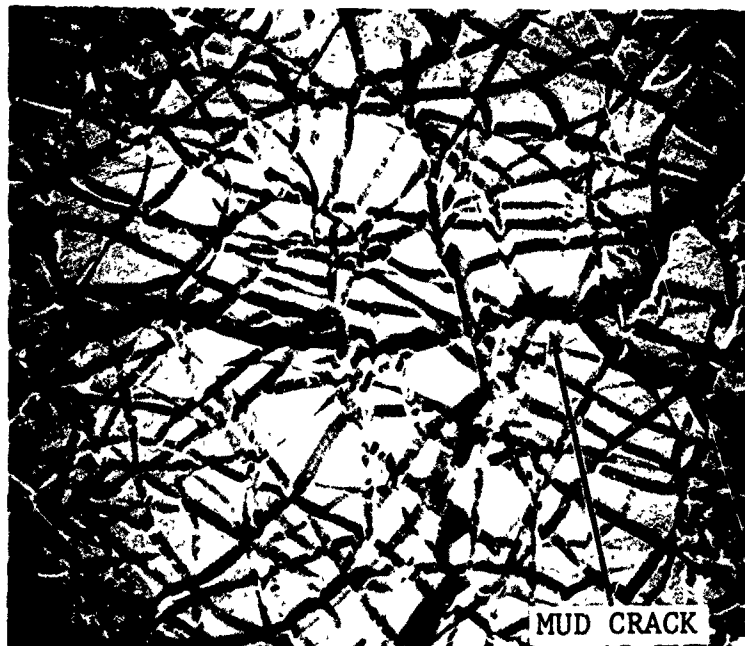
FIGURE 6. SEM PHOTOGRAPHS OF CHROMIUM PLATED SURFACE
AFTER ANODIC ETCHING

Figure 6 shows the nature of the chromium cracks when examined by the SEM. Figure 7 shows photomicrographs of cross sections through the chromium plate. The inherent discontinuous cracks (haze) are evident in the normal plate. Mud cracks are shown to be large cracks penetrating the plating; many of the cracks penetrate to the base metal.

INHERENT CRACKS IN NORMAL CHROMIUM PLATE

MUD CRACKS IN DAMAGED CHROMIUM PLATE

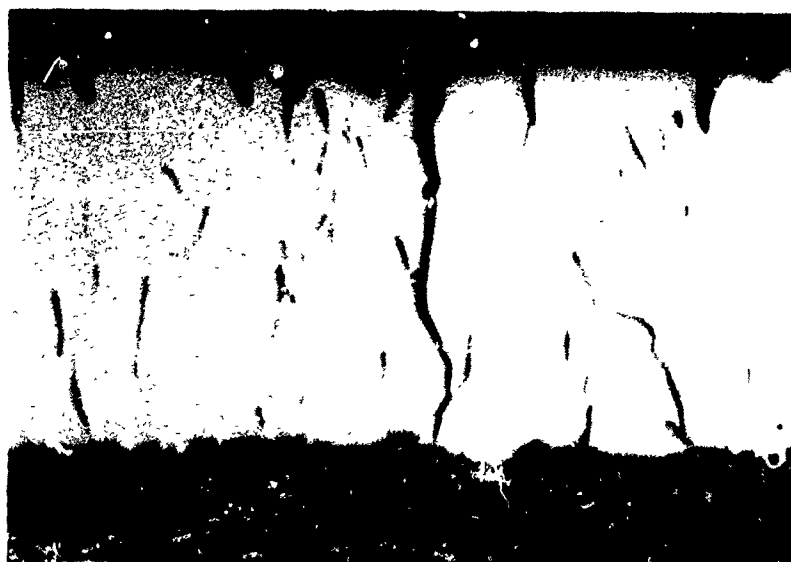
FIGURE 7. PHOTOMICROGRAPHS OF CHROMIUM PLATED STEEL
AFTER ANODIC ETCHING

MUD CRACKS THROUGH BURNED CHROME

INHERENT CRACKS IN NORMAL CHROME PLATE

Mud cracks are the only evidence of thermal damage to the chromium plate. The subsurface steel may or may not be overheated and damaged. Subsequent stripping of the chromium plate and nital etching the bare steel is the only way to determine if a part is overheated. However, if the chromium plate did reveal mud cracks, it is very important to investigate further. If there is no plate damage, the part is not overheated. Also, it is important to realize that the large mud cracks may act as stress risers for subsequent in service fatigue initiation.

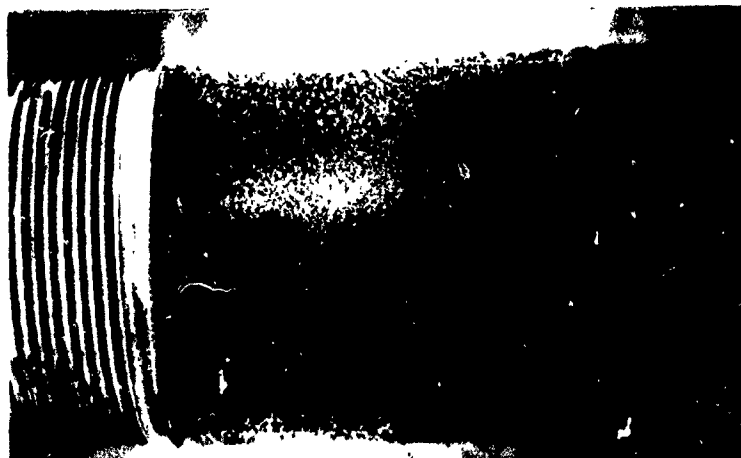
FIGURE 9. MAGNETIC PARTICLE INSPECTION ON
PIN AFTER VARIOUS OPERATIONS

Pin number four was magnetic particle inspected after etching and stripping of the plate. Photographs are shown in Figure 9. Cracks were revealed after stripping of plate that were not evident initially.

This finding is very important. It is therefore obvious that small cracks can be masked by chromium plate that magnetic particle inspection cannot detect. Only anodic etching can give an indication that such cracks may exist. This is of course by indirect means - grinding damage revealed on the chromium plate requires further investigation and stripping of the plate, which will permit detection of the cracks.

CHROMIUM PLATED

HIGH INTENSITY INSPECTION AFTER ANODIC ETCHING

CRACKS REVEALED AFTER STRIPPING CHROMIUM PLATE
